# **QUARTERLY SITE INSPECTION REPORT**

## **BAILEY SUPERFUND SITE ORANGE COUNTY, TEXAS**

MAY 29, 1998

PREPARED BY: CECOS INTERNATIONAL, INC.

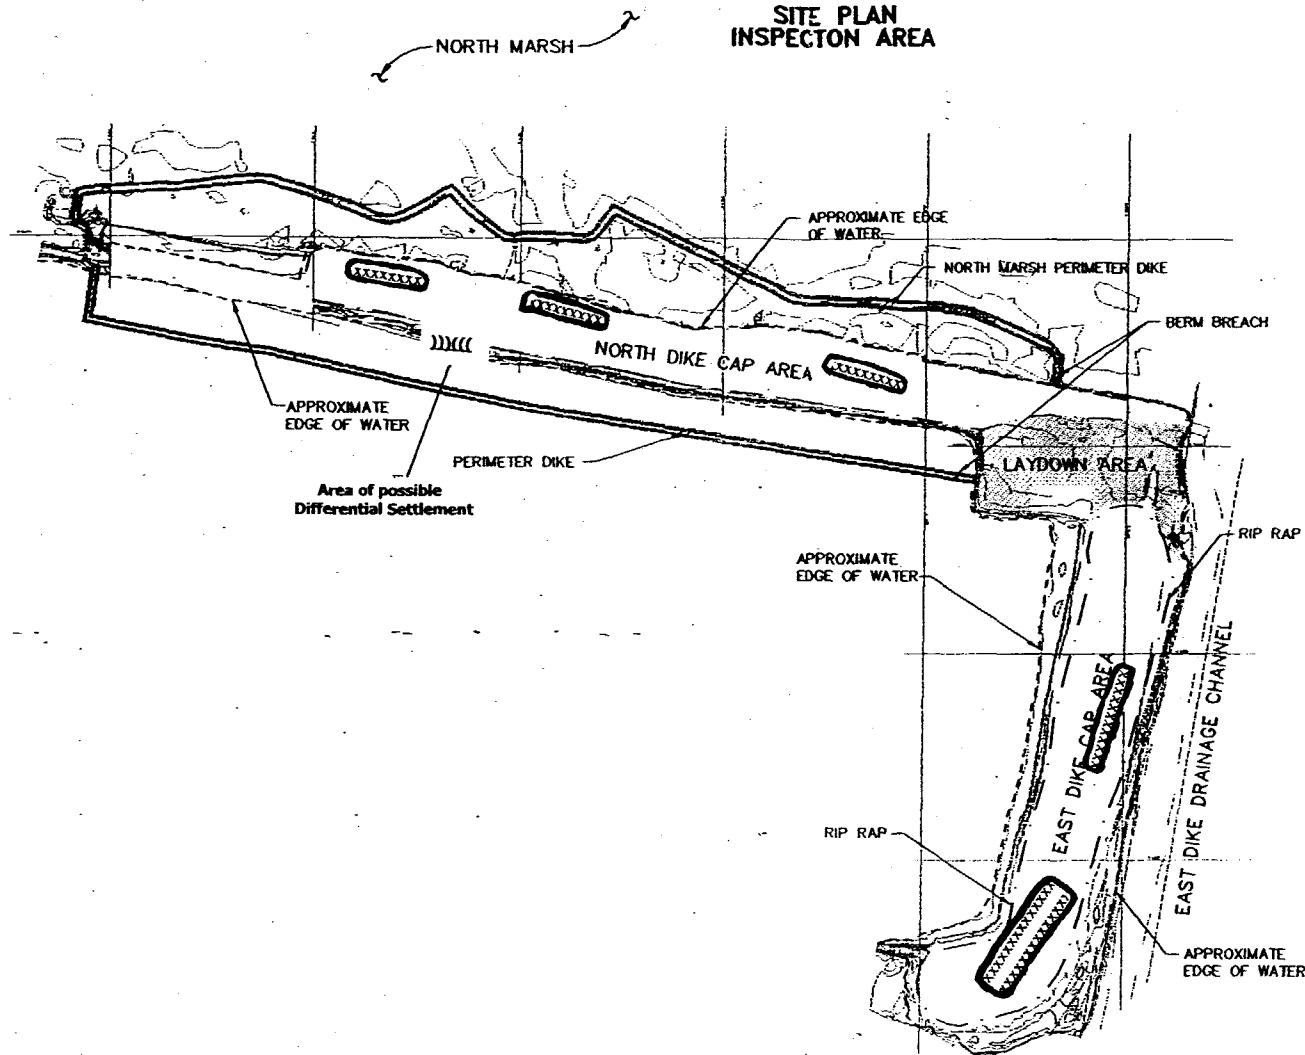
# **SITE PLAN INSPECTION AREA**

Desiccation cracking of the topsoil was observed on both the North and East Dike areas. The desiccation cracks were observed to be mainly concentrated on the south end of the East Dike and near the center of the North Dike Area. A map is provided in Appendix B that details where desiccation cracking was observed. The largest cracks observed were approximately 2" wide, approximately 10" deep, and and greater than 10 feet in length. It appeared that some of the cracks may extend nearly down to the geosynthetic composite liner surface, however no liner was visible through any of the cracks.

Possible differential settlement was observed in a small area of the rip-rap slope located outside of the geosynthetic lightweight cap limits on the North Dike. No signs of differential settlement were observed on the adjacent cap areas. This location was noted on the map included in Appendix B.

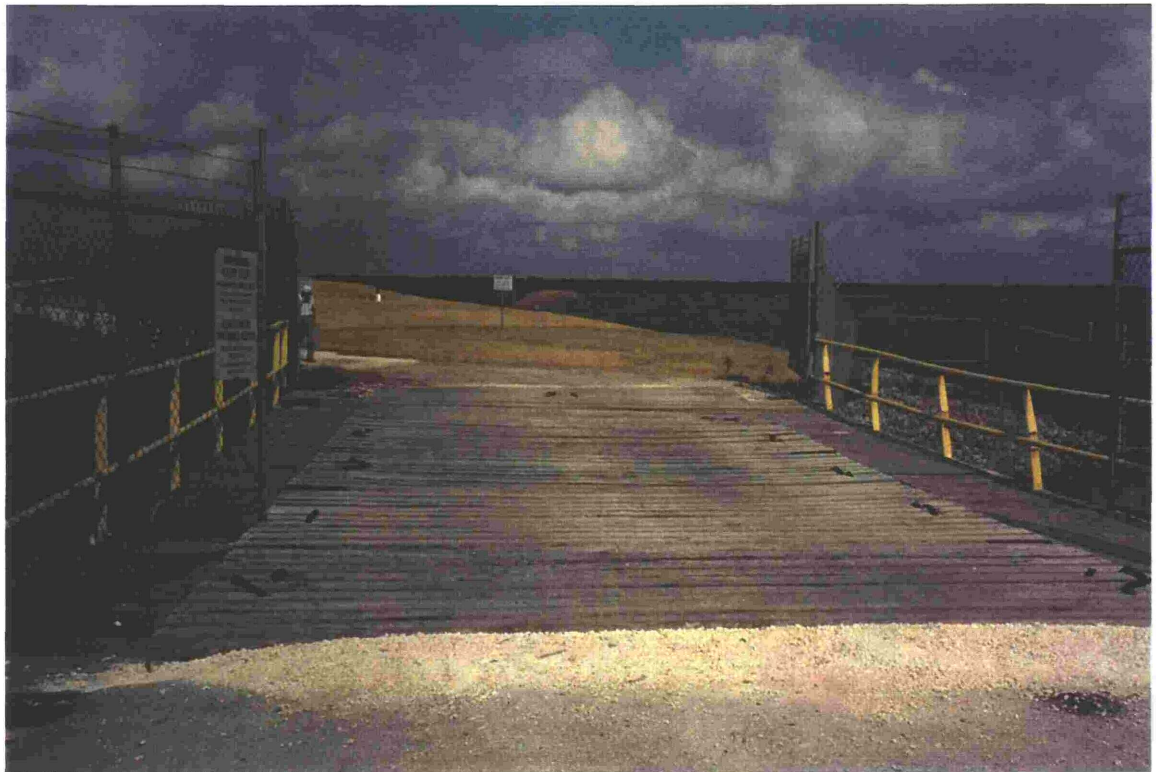
Bridge at Front Entrance  
Good Condition  
All signs, locks, and handrails are in good condition  
10:00 a.m. on May 29, 1998

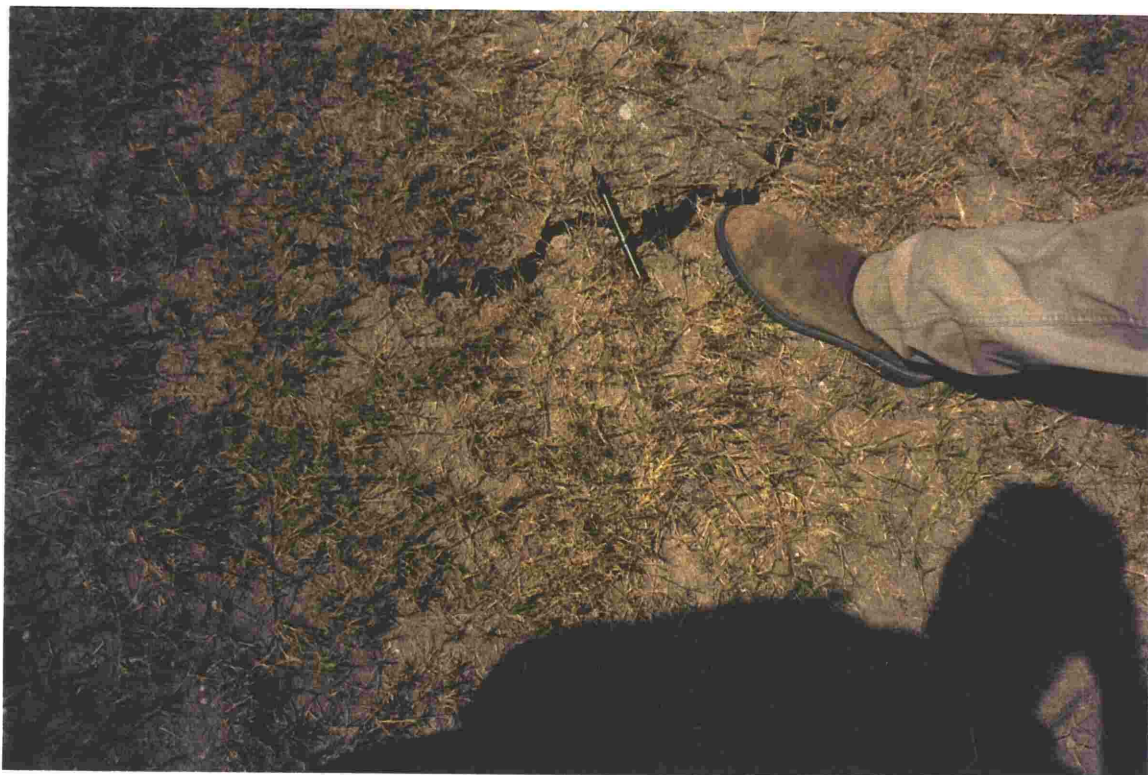
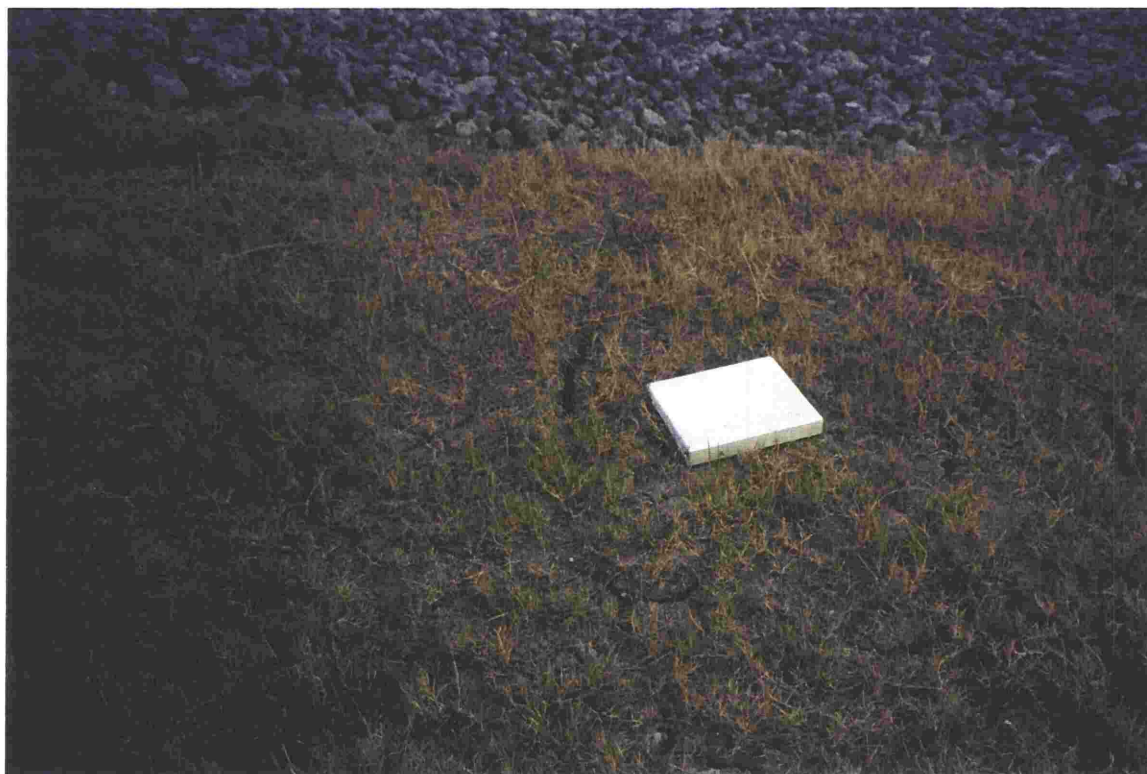
The lack of rainfall at the site has caused desiccation cracking of the topsoil and the vegetation to be distressed.

Cracking of the topsoil layer-  
North side of North Dike  
10:15 a.m. on May 29, 1998

Rain gauges are to be placed on the site and monitored. If no significant rainfall is observed at the site within a week of the inspection, a recommendation will be made to begin importing water to the site and begin watering of the vegetative cover to prevent losing the vegetation already established to date. The site will be inspected to locate the most distressed areas of vegetation and desiccation cracking. The watering operations will concentrate on those areas first prior to watering the remainder of the site. Water trucks will not be allowed off the access roads and will spray water from the roads onto the vegetation. The desiccation cracks will be closely monitored. Any cracks greater than two inches in width and threaten to expose the geosynthetic composite liner will be filled in with loose topsoil from the soil stockpile area.

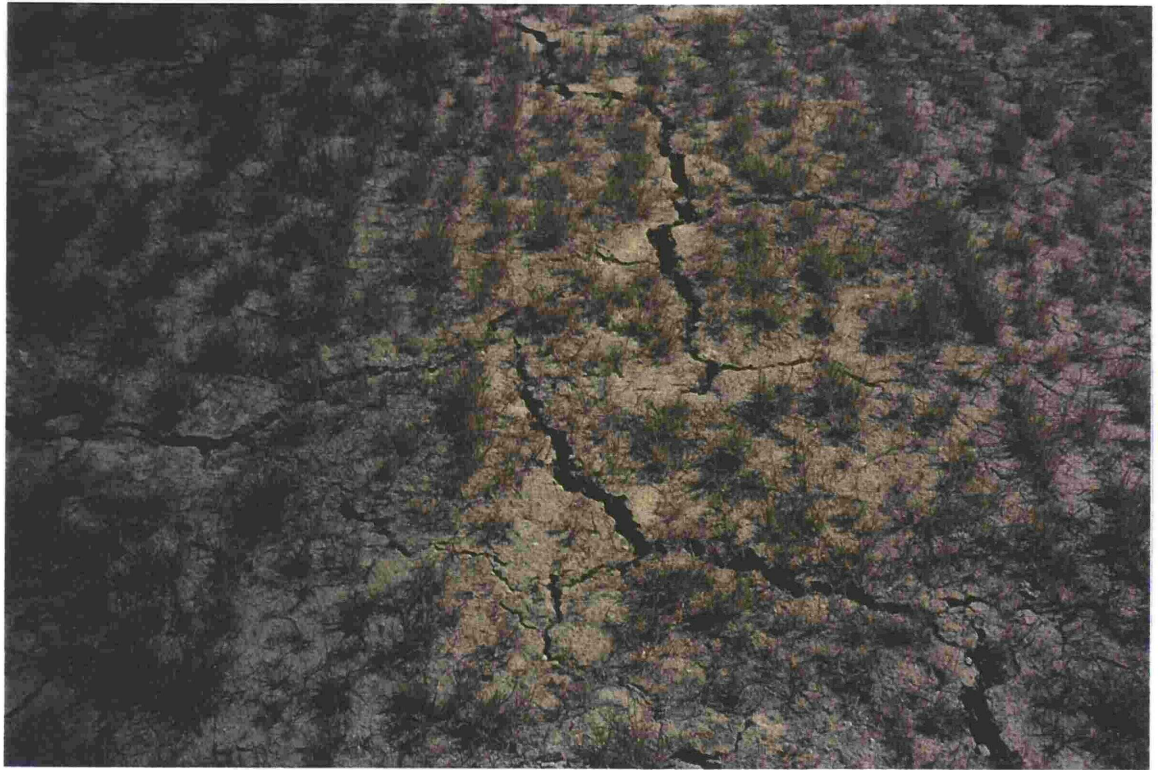
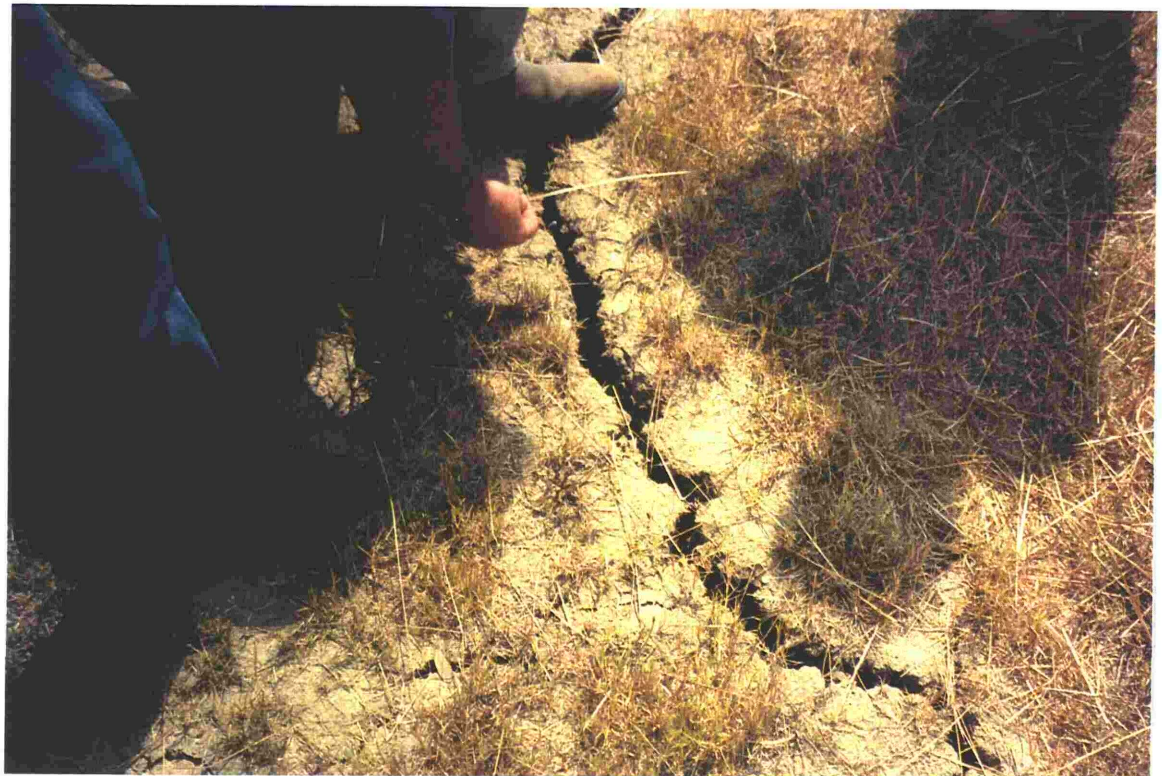
Cracking of the topsoil layer- (Up to 12 inches in depth)  
South side of East Dike  
10:55 a.m. on May 29, 1998

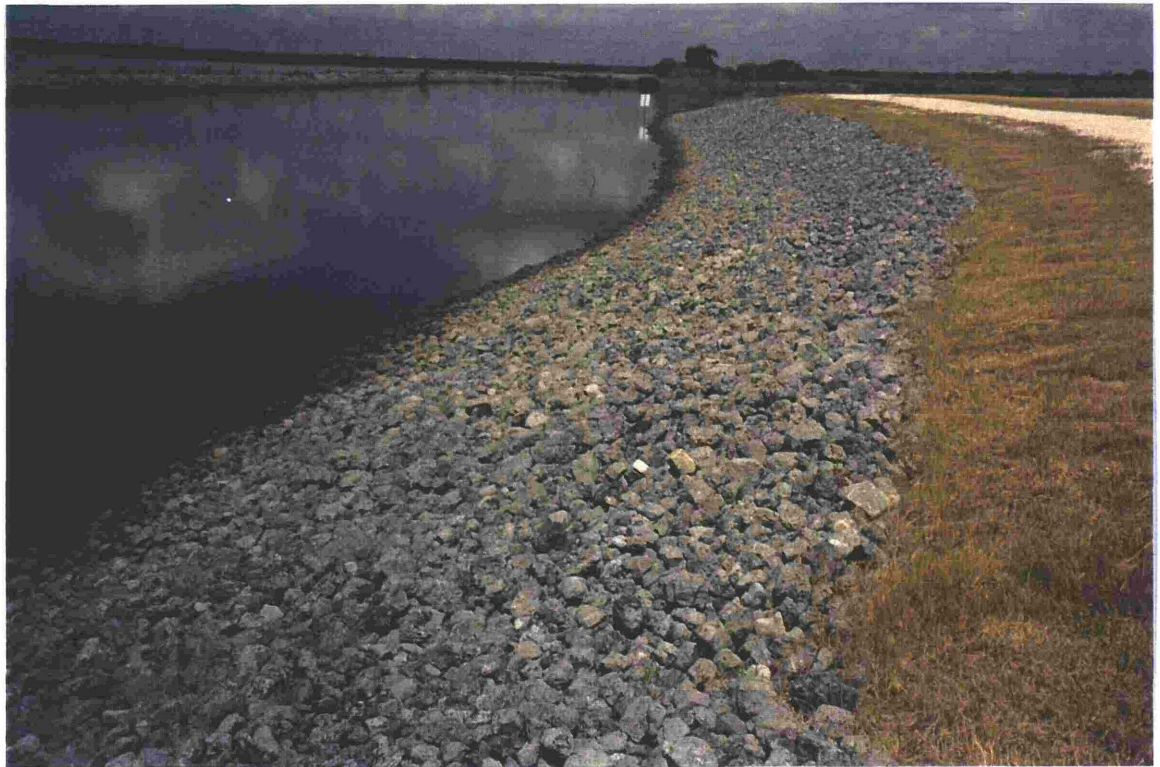
Area of possible subsidence (rip-rap material)  
 South side of North Dike  
 10:30 a.m. on May 29, 1998

Continue visual monitoring of this area.

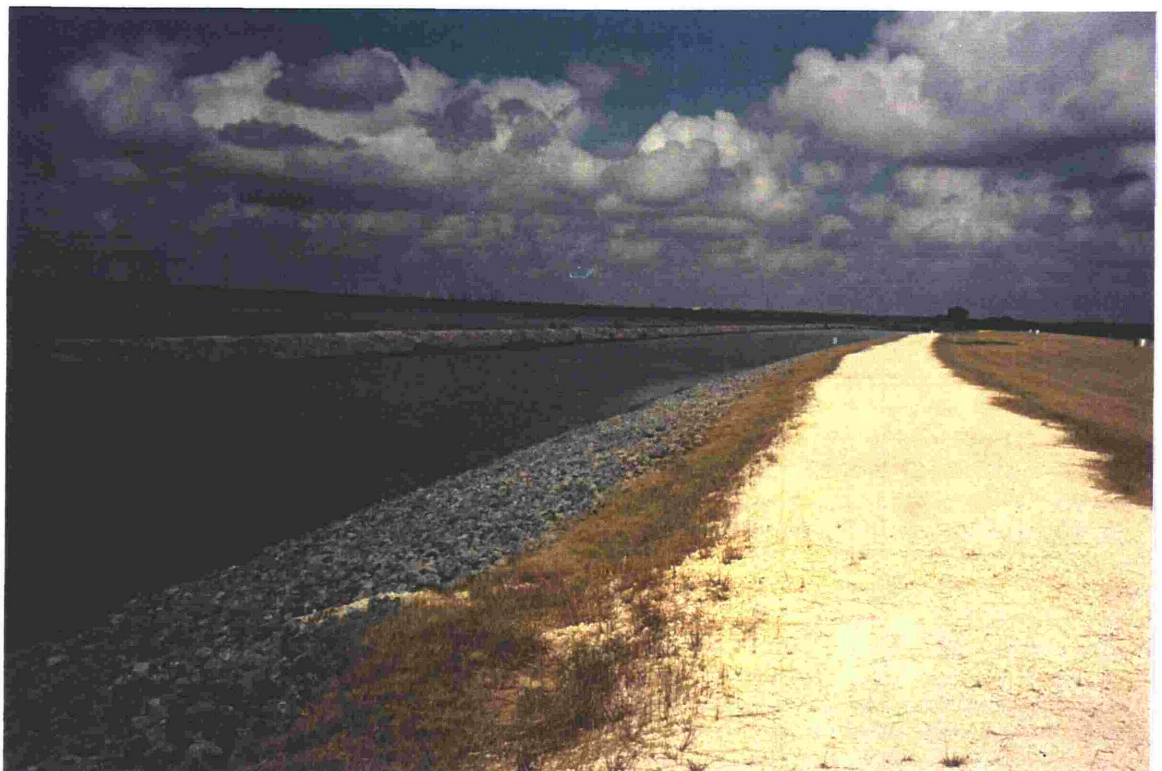
Rip-rap material in good condition  
 South side of North Dike  
 10:35 a.m. on May 29, 1998

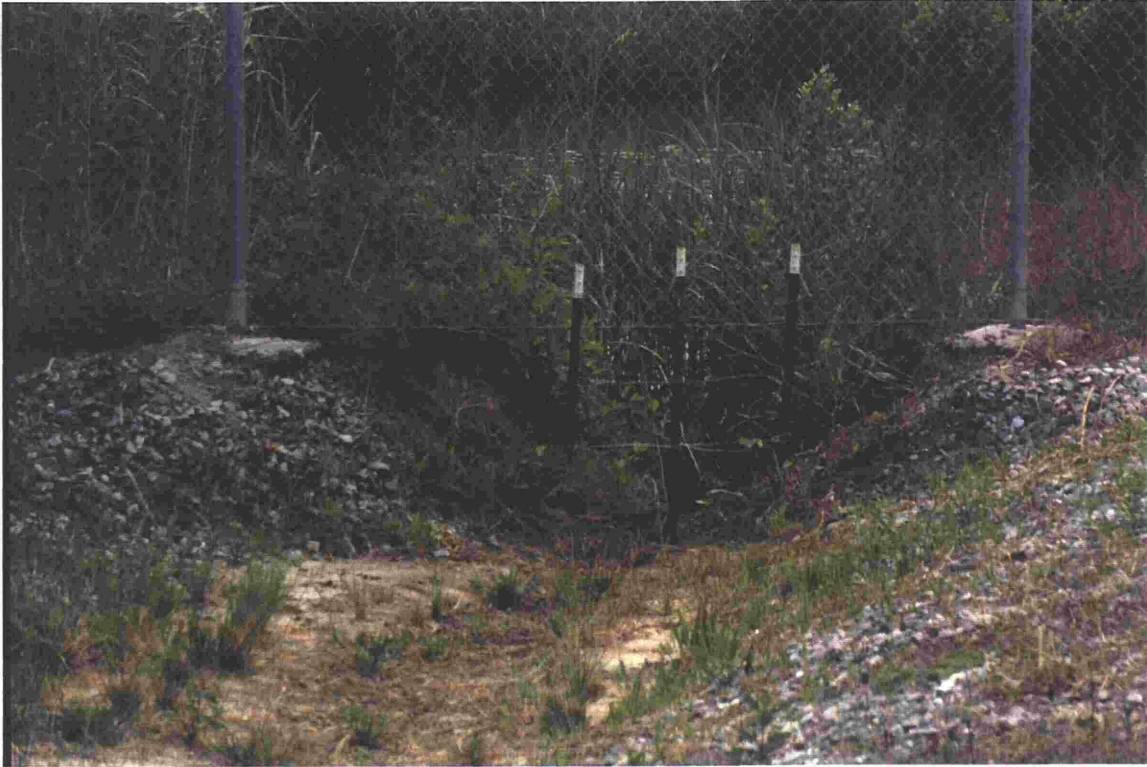
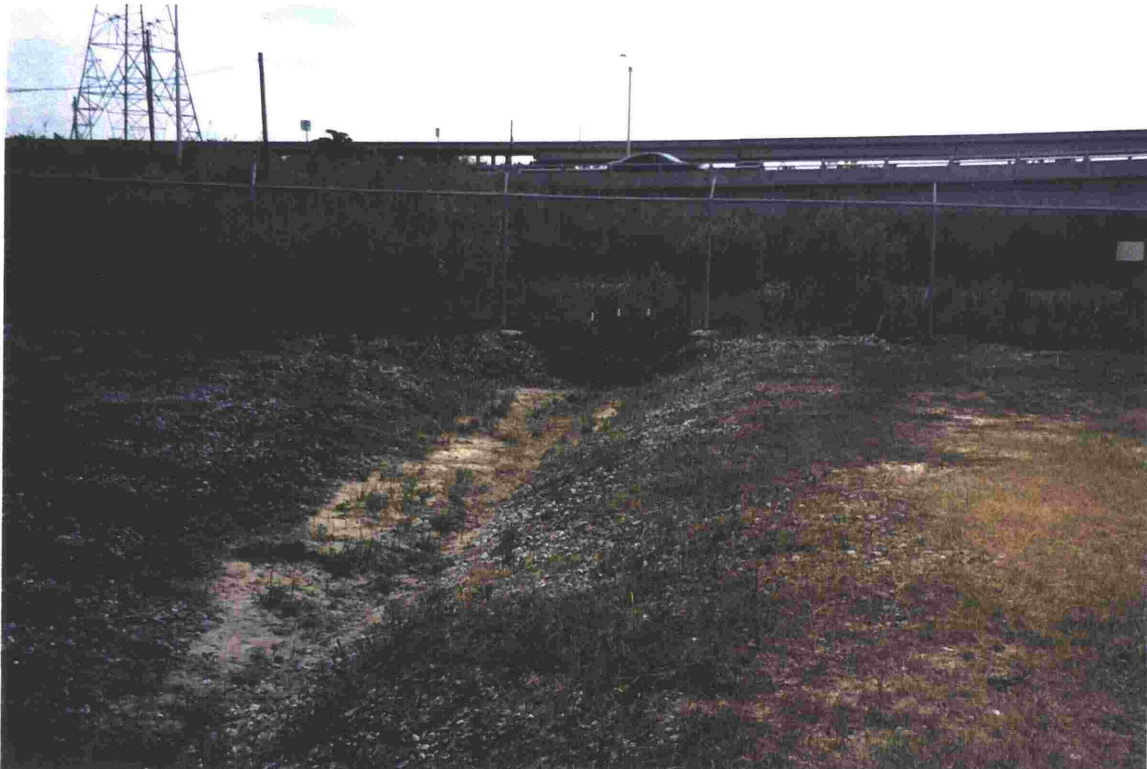
- Modifications to the security fence have been made in the former laydown yard. Post and barbed wire were added at the drainage ditch locations to prevent access to the site by allowing someone to crawl underneath the fence at these locations.
- Old silt fence construction debris near the East Dike entrance was picked up and properly disposed of off-site.

East Fence of Laydown Yard  
Security measures taken to elude trespassing  
11:05 a.m. on May 29, 1998

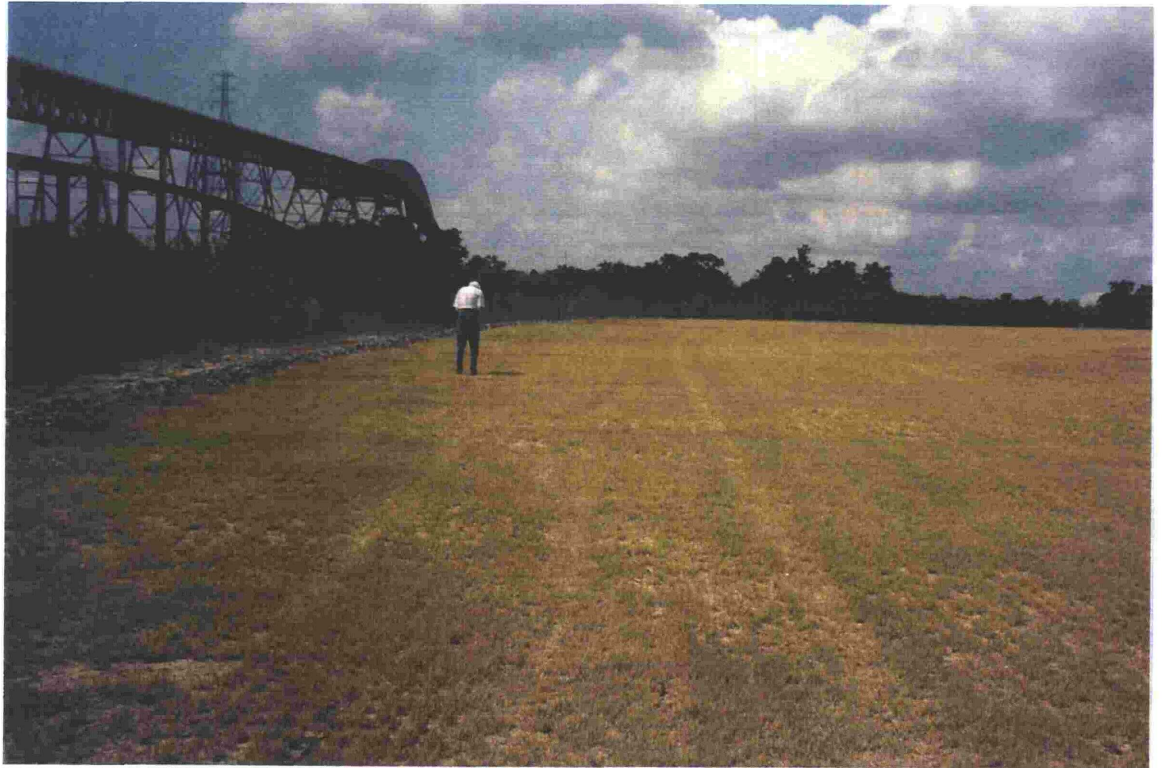
Condition of Vegetative Cover (stressed)  
East Dike looking southward  
10:50 a.m. on May 29, 1998

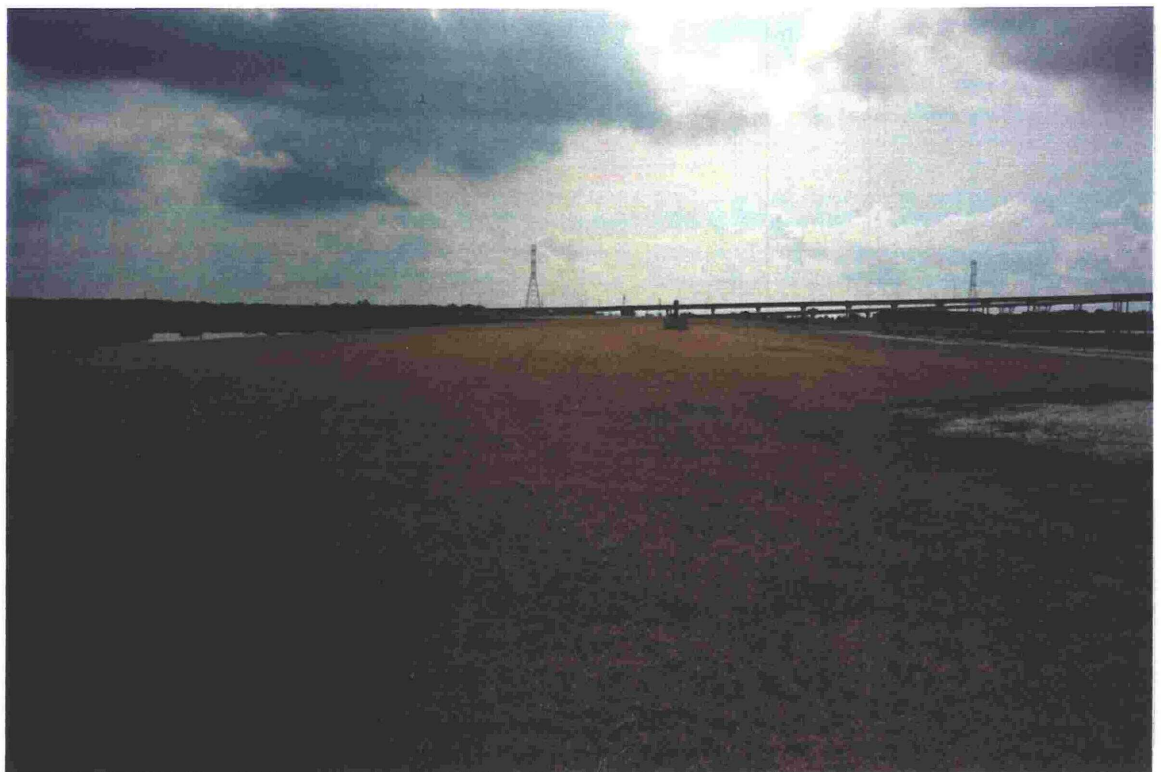
Condition of Vegetative Cover (stressed)  
North Dike looking eastward  
10:10 a.m. on May 29, 1998

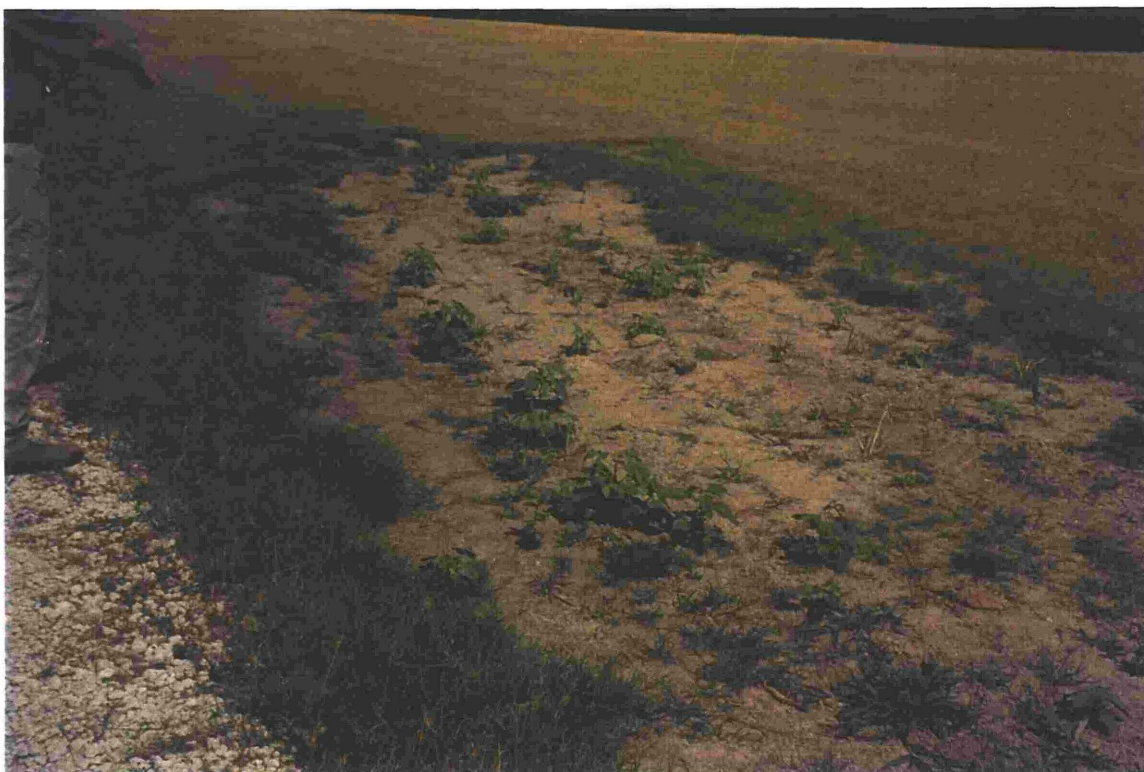
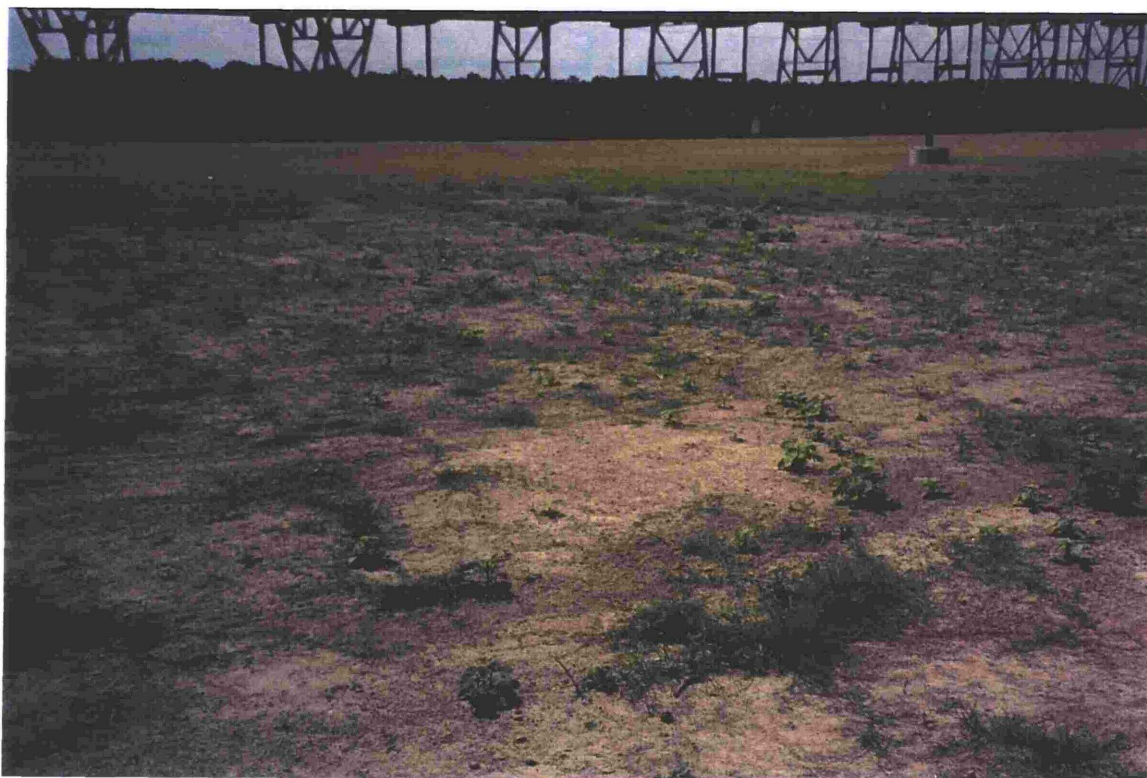
There are still areas as noted from the February 1998 Quarterly Inspection that need to be reseeded and fertilized.

Areas of general fill placement due to findings of the February 29, 1998 Inspection. Areas were filled with topsoil, fertilized, and seeded by American Remediation Company.  
10:45 a.m. on May 29, 1998

Perform this work as site conditions warrant. The recommendations from the Texas A&M Agricultural Extension Office for fertilizer type and application rate should be followed. Re-seeding and fertilizing should be performed when the moisture conditions on the topsoil will sustain new growth.

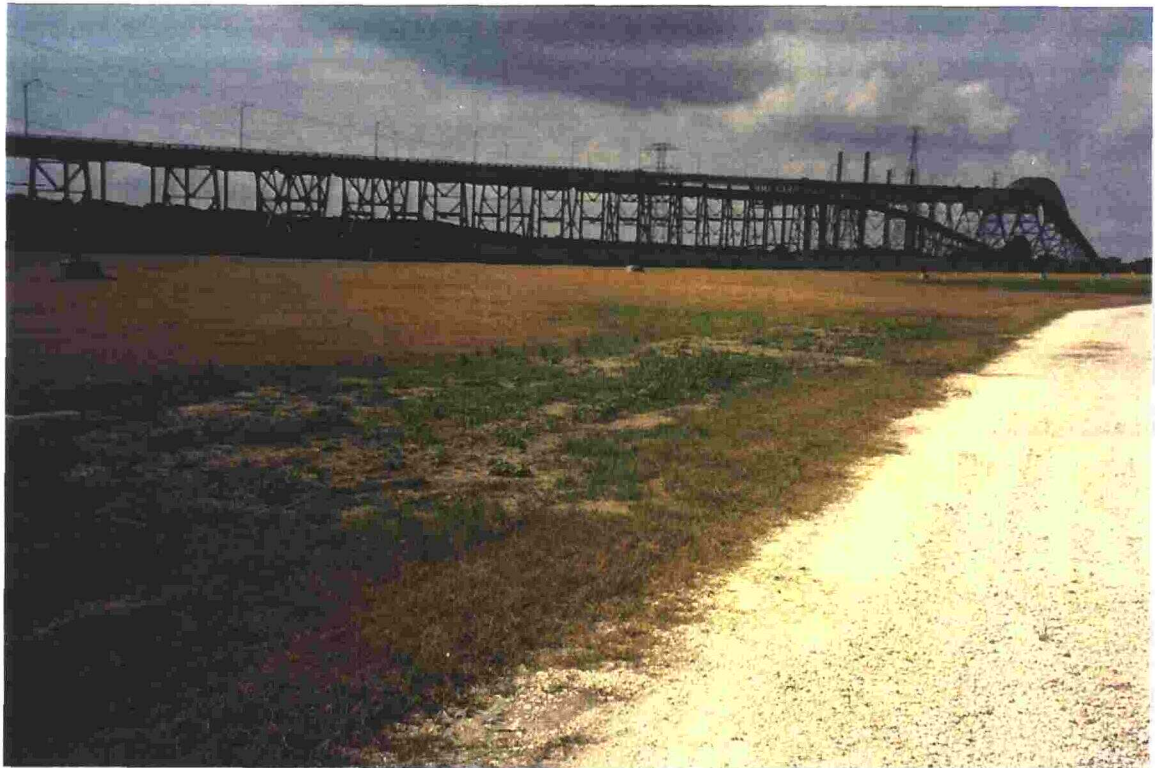
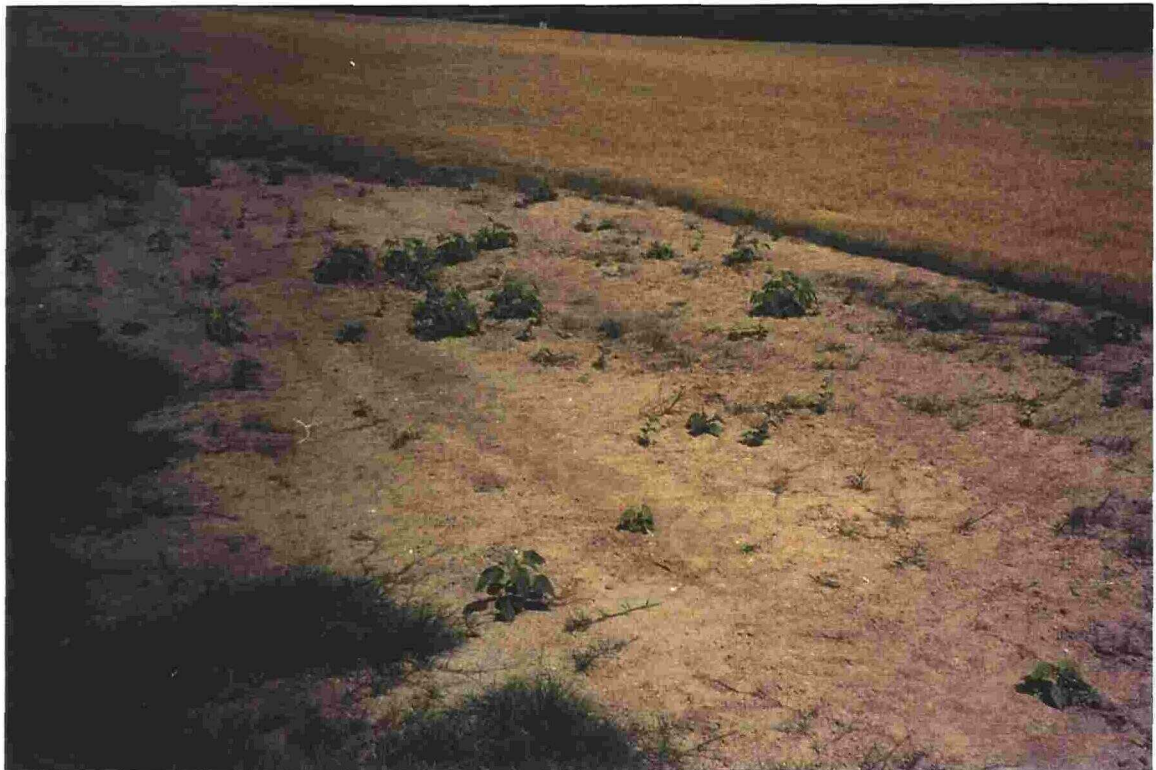
Areas of general fill placement due to findings of the February 29, 1998 Inspection. Areas were filled with topsoil, fertilized, and seeded by American Remediation Company.  
10:45 a.m. on May 29, 1998

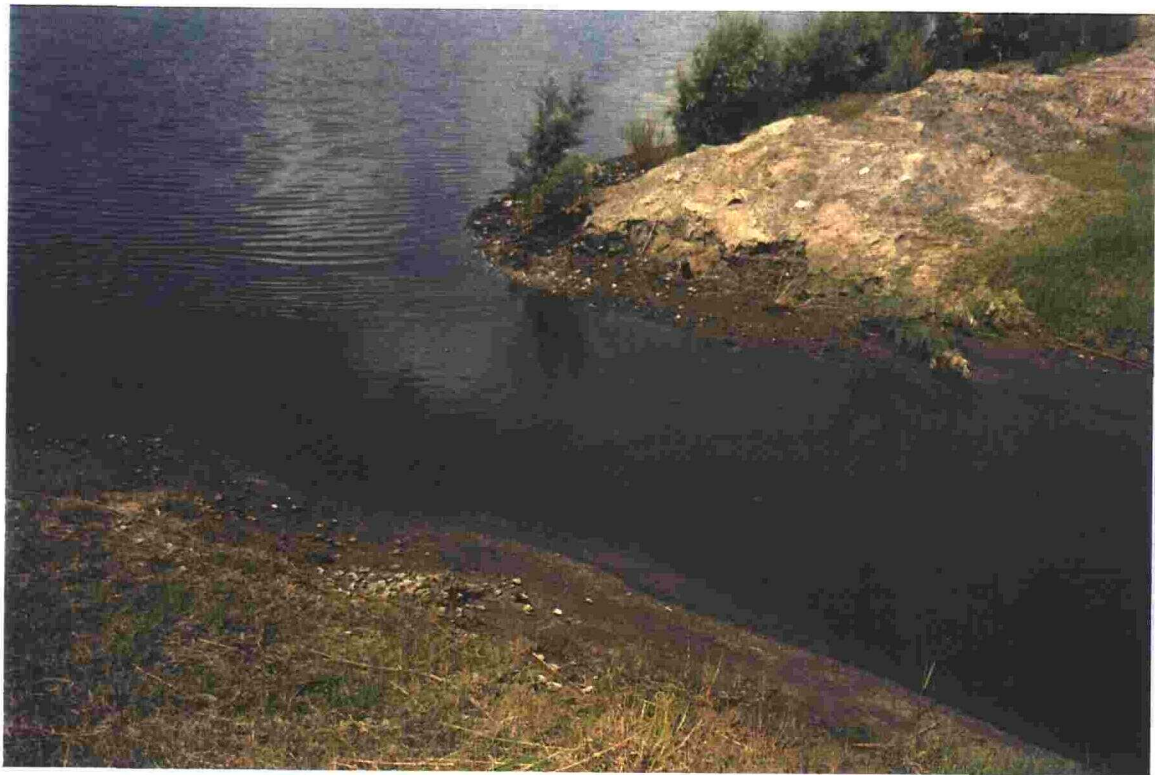
Tidal Flow (Northeast corner, Pond A, adjacent to Laydown Yard)  
Free of obstructions  
10:38 a.m. on May 29, 1998

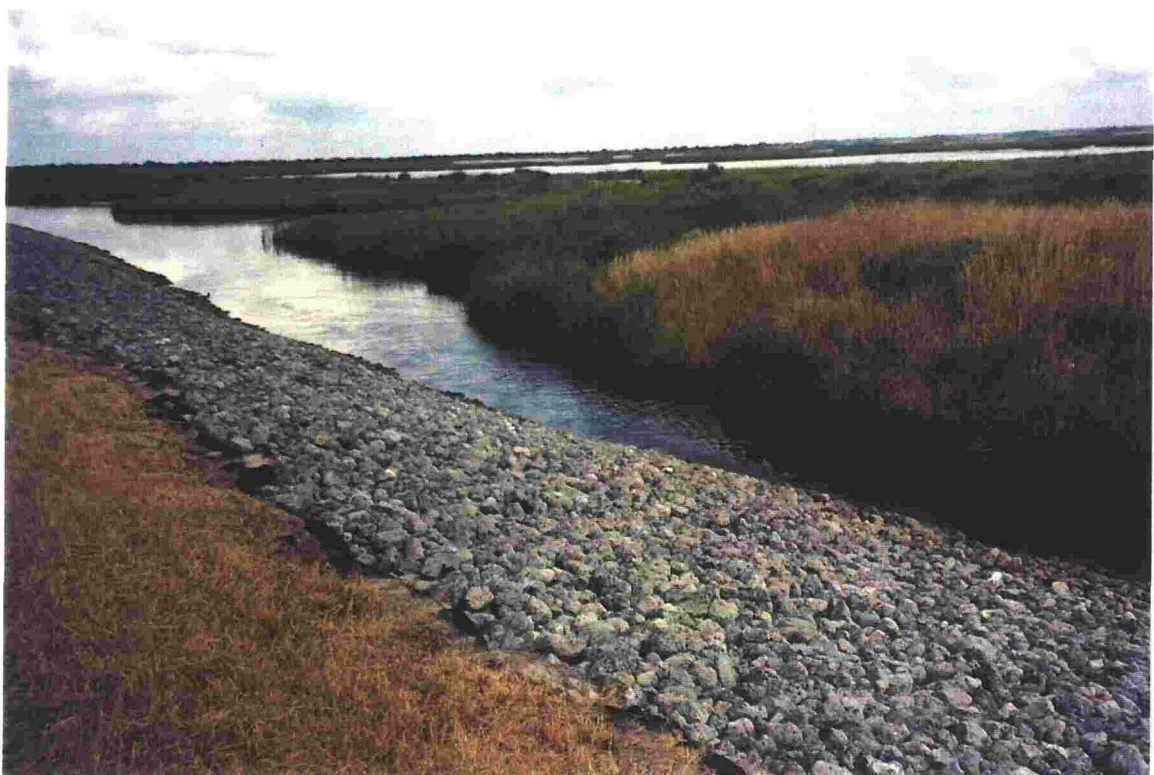
Tidal Flow (North side of North Dike)  
Free of obstructions  
10:20 a.m. on May 29, 1998
